# 1. Historic and Cultural Value

*In re - Bridge at Bishops Ford*

pennsylvania DEPARTMENT OF TRANSPORTATION		PRESEVATION/REHAB PLANS REVIEW REVIEW COMMENTS		McCORMICK TAYLOR	
Project: Bishop Bridge Preservation/Rehab Project					
Subject: Preservation / Rehab Plan					
Designer: Wrought Iron Bridge Works					
Date Received: April 19th 2025					
Review Date: June 8th 2025					
Reviewer(s): Derek Mitch, PennDOT District Bridge Engineer; Brandon Newpher, McCormick Taylor					
Status: Accepted As Noted, Provide Resubmission for Approval

SUBJECT: Preservation / Restoration of Bishop Road Bridge

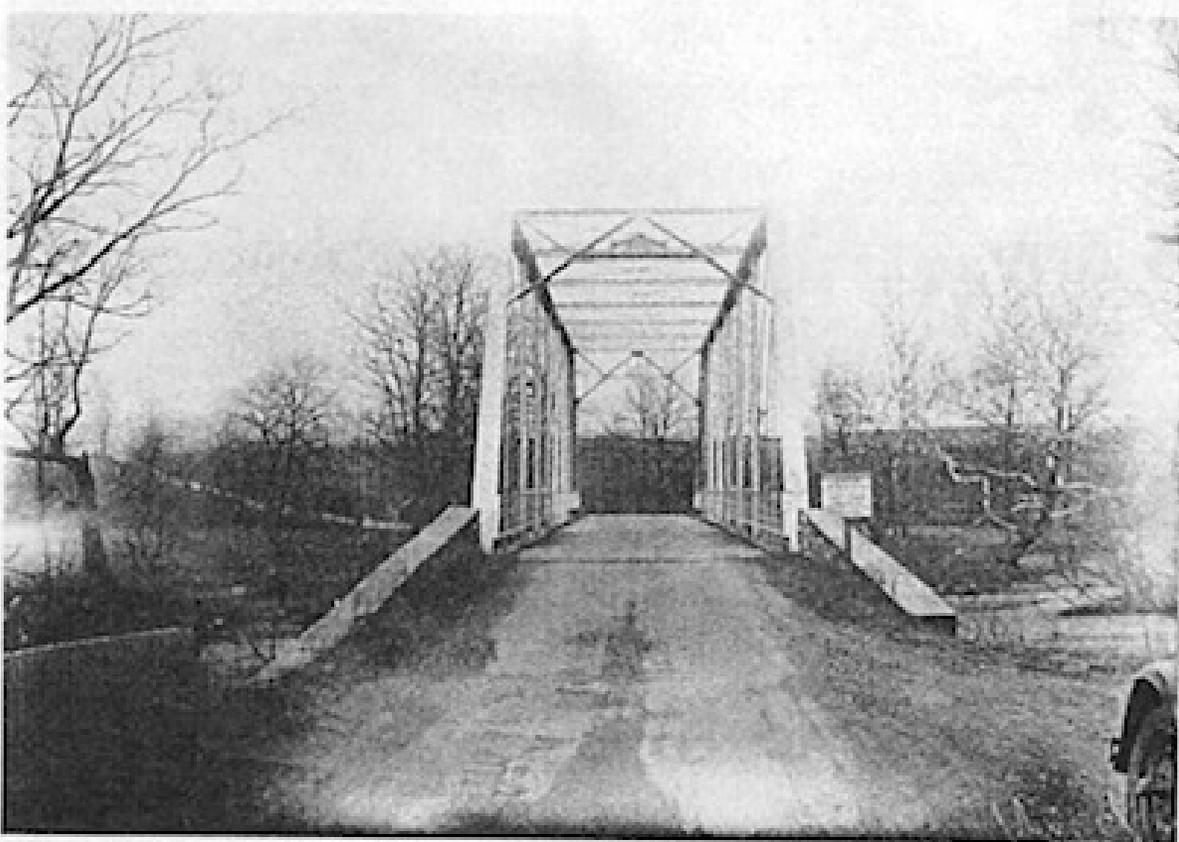
*Bishops Bridge*

—CCHS, Donated by County Commissioners, 1933

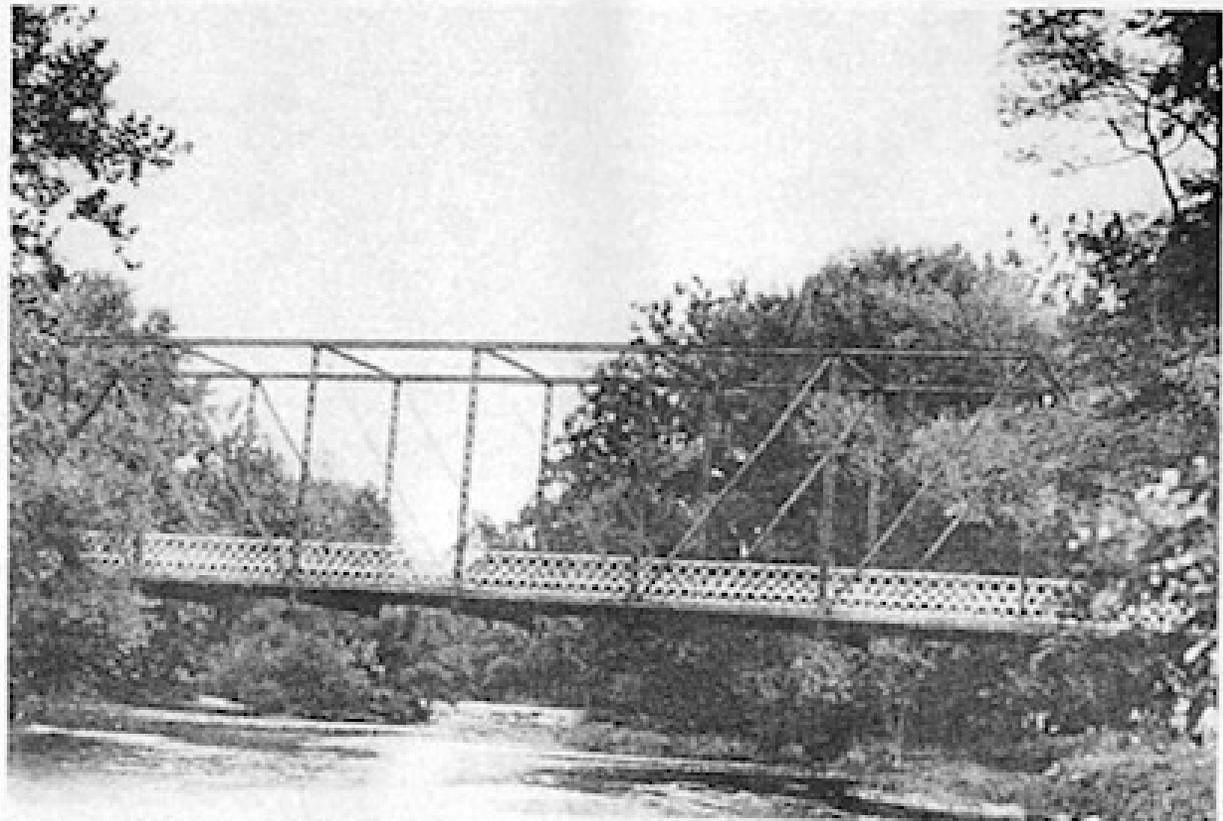
*Bishops Bridge*

—CCHS, York County Archives, 1926

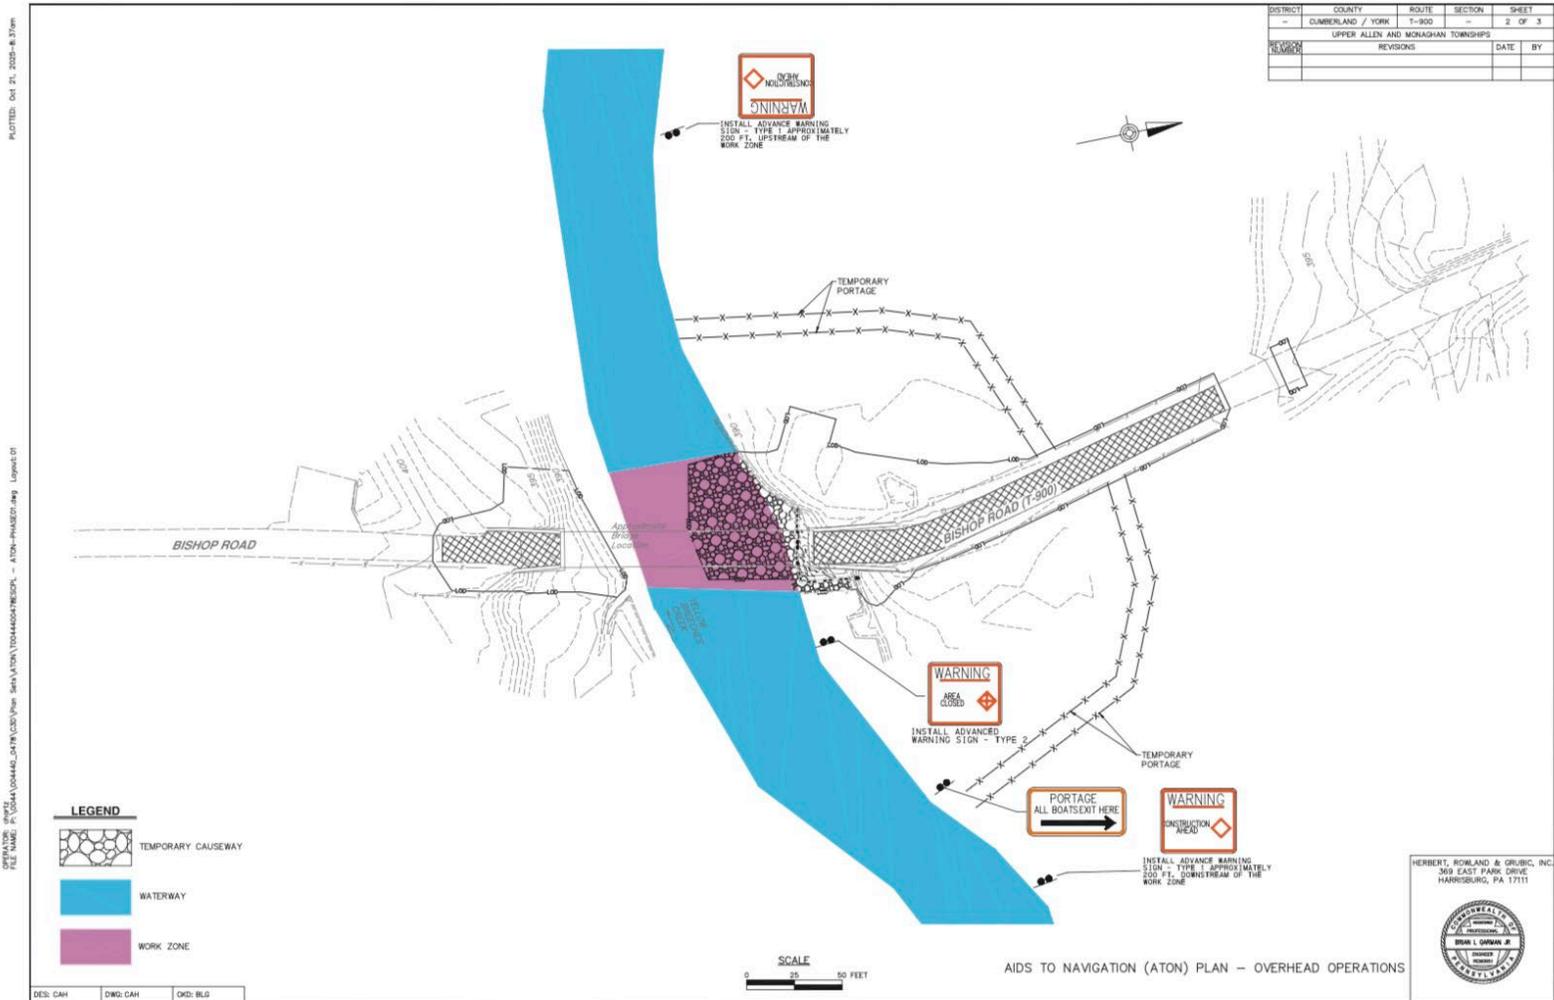
*ATON plan drawing from County bid documents*

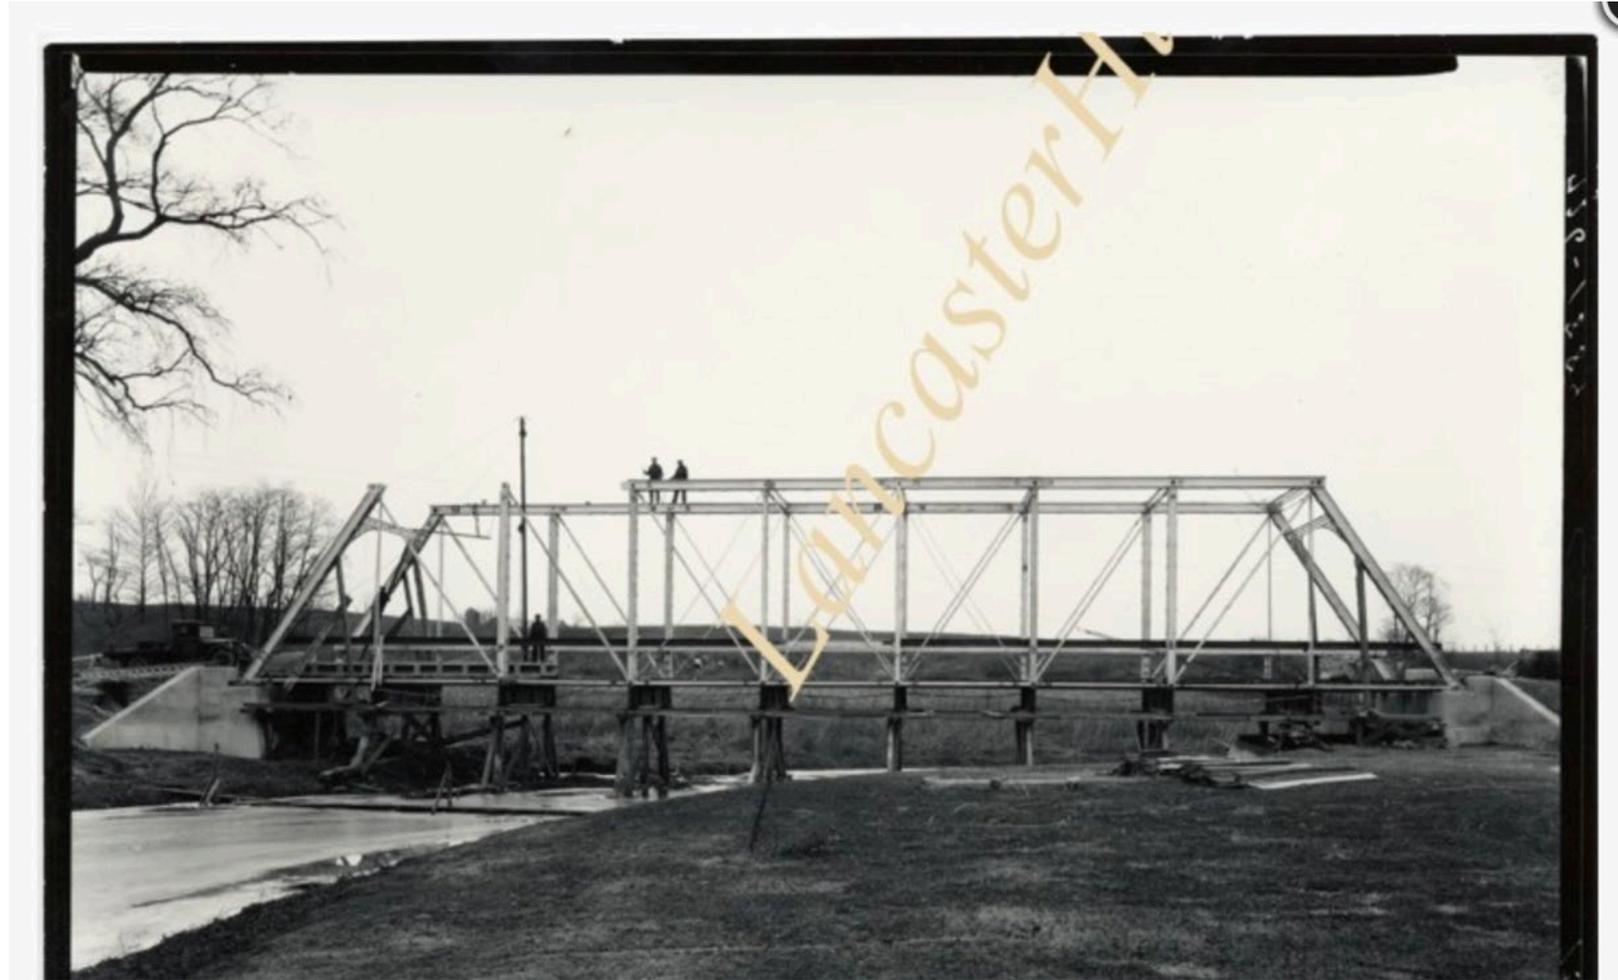
*Historic use of false work and gin pole ca. 1920's*

- c. Assemble falsework and jacks. Note: the falsework will rest on the stream bottom on padded plates with a load distribution of below 25psi
  - d. Disassemble bridge. Catalog/match-mark all components.

4. Erection \$250,000. Upon submission of load rating documents:
- a. The falsework, jacks, stringers and deck will be reinstalled followed by erection of the truss (as done originally in 1898).

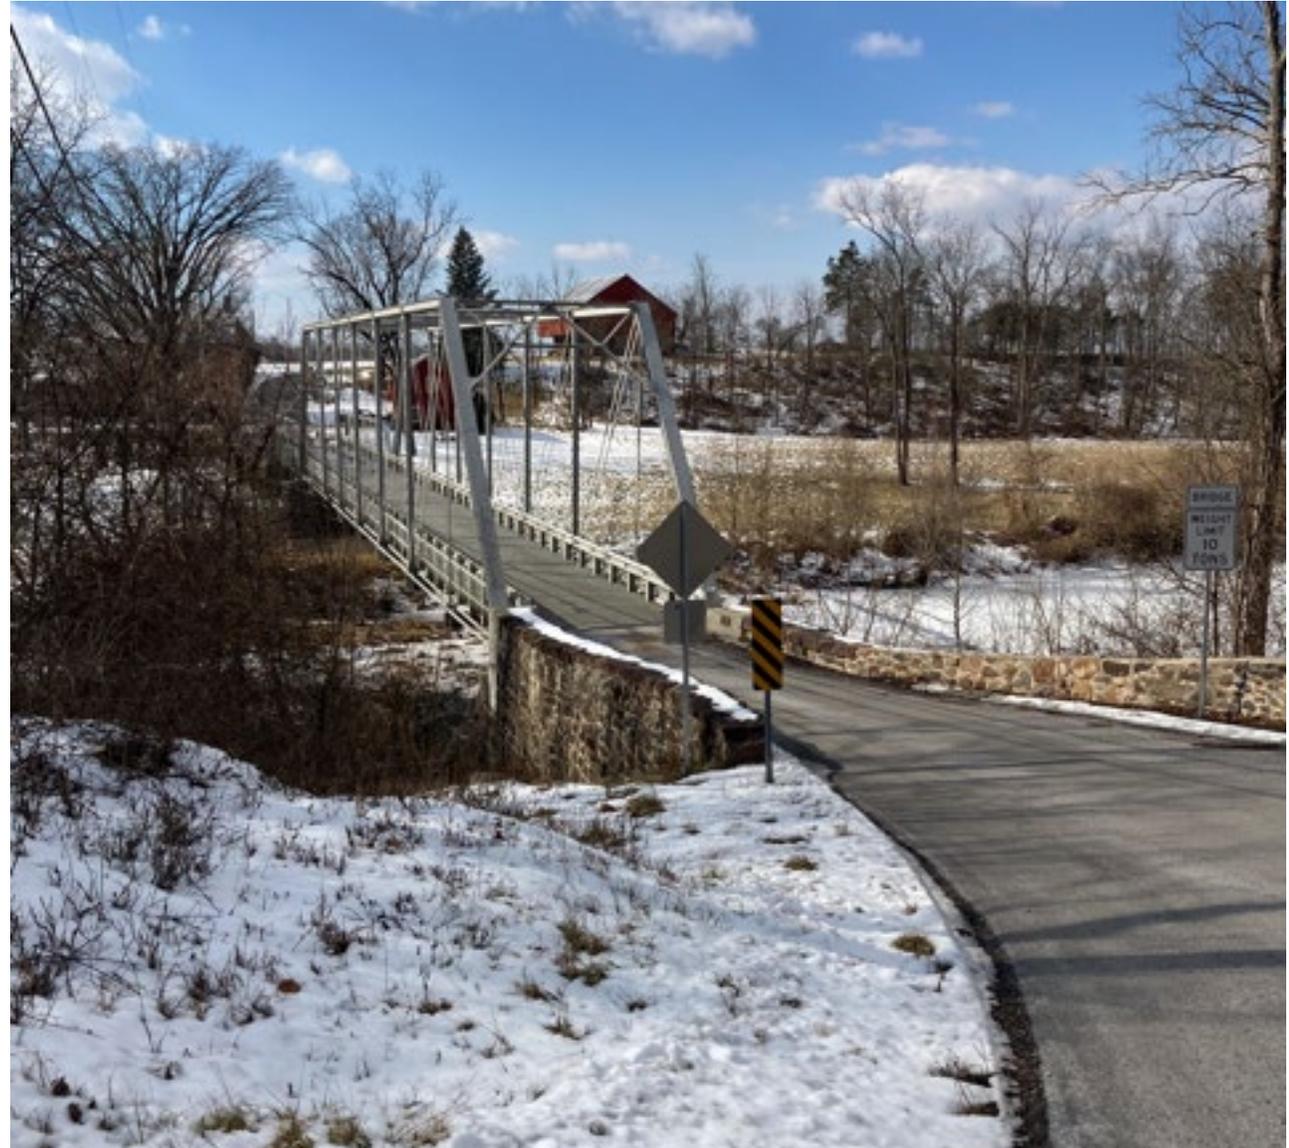
*Hull Drive Bridge near Dillsburg  
(rehabilitated 2019)*

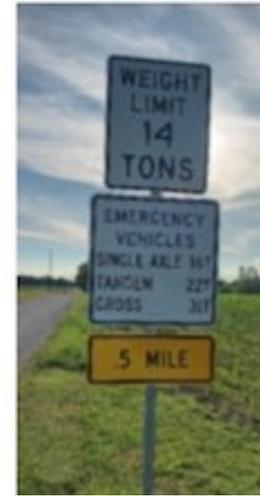
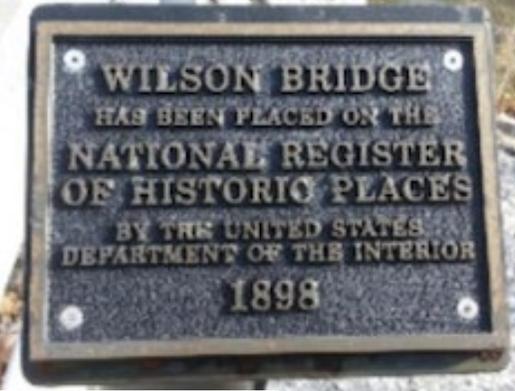
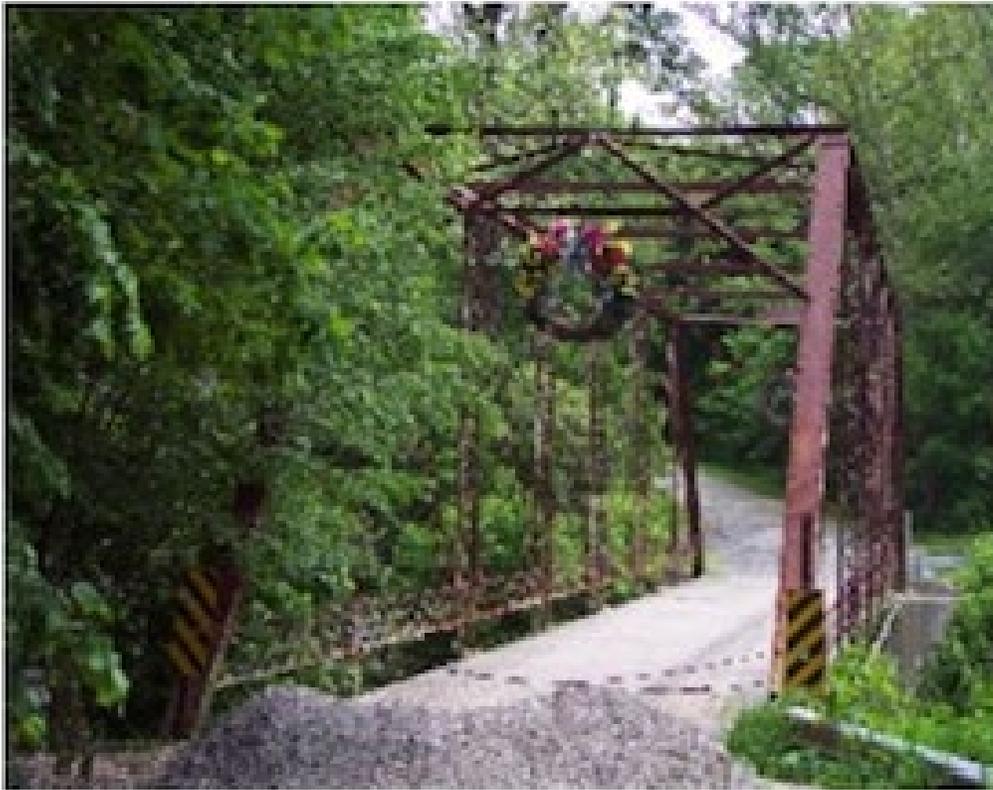
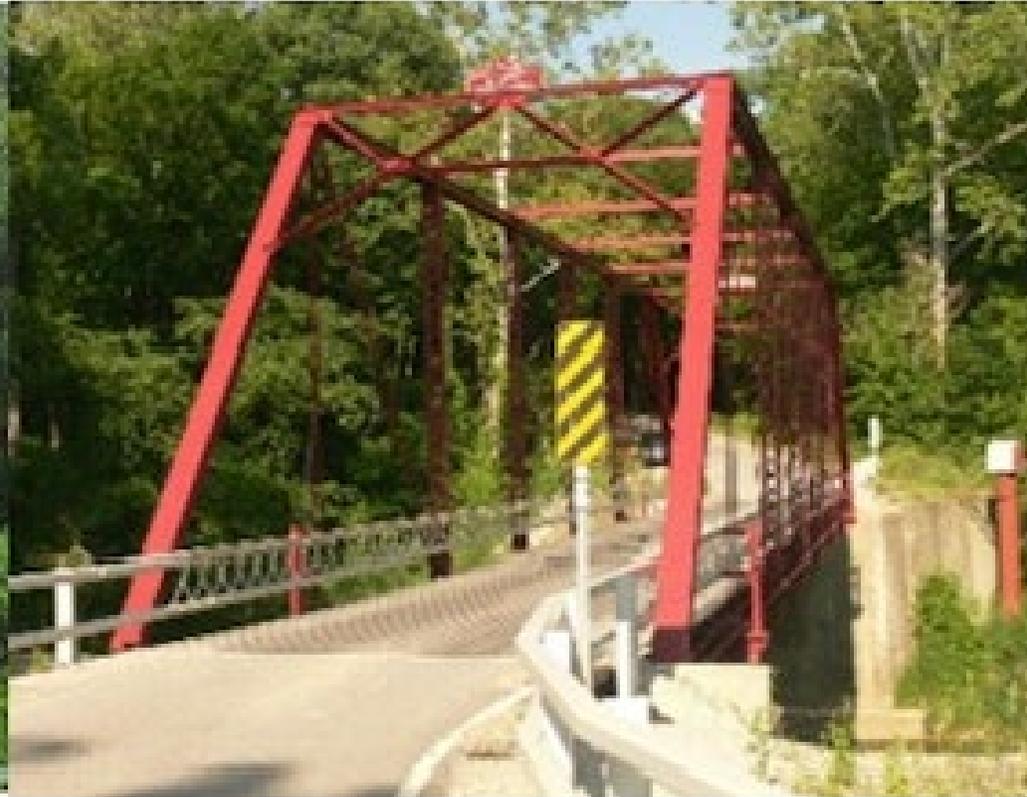
*Wilson Bridge before and after*
